Hysham Notes for 2/01/2023
Permanganate Optimization and Filter Inspection

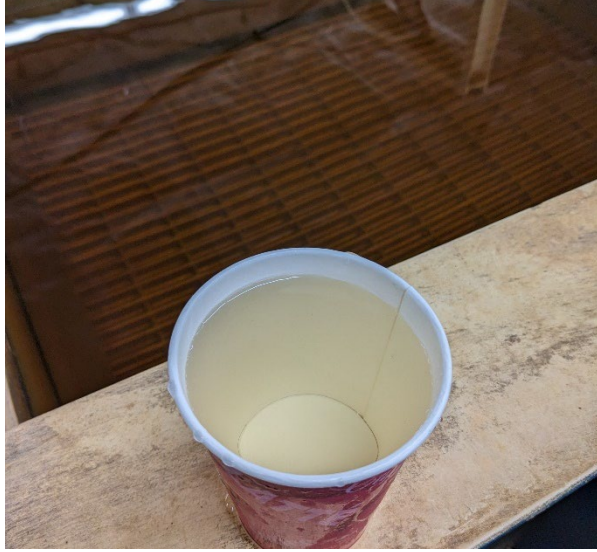
Figure 1 – Top of filter water after increasing permanganate additions. A spot check at 2 ppm permanganate was 4 NTU turbidity.

- We worked permanganate rate up to 2.0 ppm using the schedule above. The top of filters turned from clear to brown as the permanganate rate increased as shown in Figure 1. We monitored the top of filters closely for pink color breakthrough indicating permanganate additions might need to be reduced, but never observed pink.

- Although the floc was very small in the brown water at top of filters, the filters were effective at removing the color. Turbidity of the brown water was measured at 4 NTU. Turbidity of the filtered water stayed below 0.100 before and during testing. Clear well turbidity started improving on Friday and was down to 0.624 (from 0.9-1.2) by Friday at 1 pm.

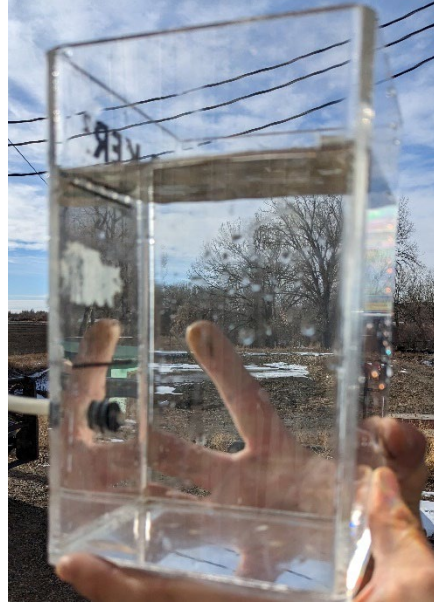
Figure 2 – Filter effluent water. The calibrated turbidity analyzer was indicating in the 0.050 NTU range.

- We also monitored filter effluent closely and observed clear liquid as shown in Figure 2 with the increased permanganate usage.
 - We had concern that we could not see flock in the brown water at top of filters. We did a very approximate jar test to see if more chemical additions might be supported. The test samples were:

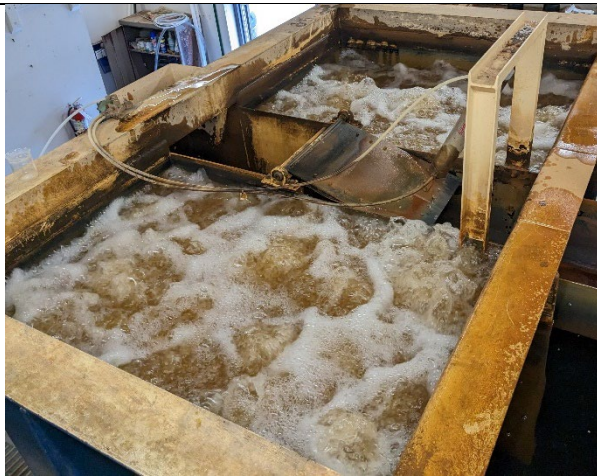
Figure 3 – Typical bead chamber air scour.

- Air scour of the bead chamber after a few hours of operation at higher permanganate rates showed a significant amount of material was being removed from the system / water. The air scour normally looks like Figure 3. The scour looked like Figure 4 after the permanganate was increased. It seemed that there is more material being removed than could be explained by iron and manganese in the feed water, so we suspect material is being removed from the system / beads. We will monitor if air scour operations show reduced red colorations after operating at the increased permanganate rates for a few days.

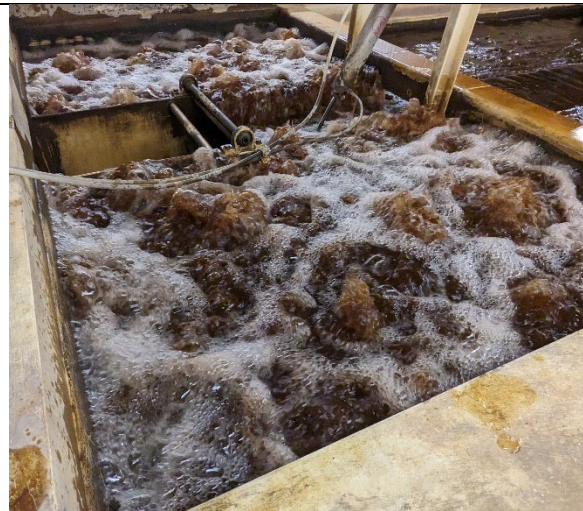
Figure 4 – Bead chamber air scour after a few hours of increase permanganate additions.
